Overcladding

external walls of large panel system dwellings

H W Harrison, J H Hunt and J Thomson

Department of the Environment
Building Research Establishment
Building Research Station
Garston
Watford
WD2 7JR

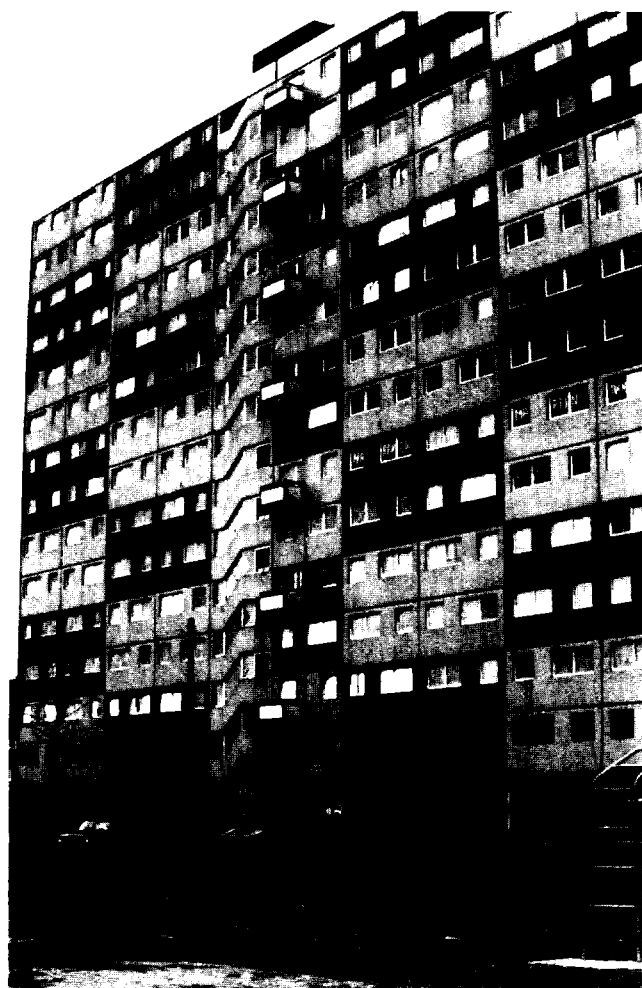
Figure 2 Derelict Tracoba block at Sandwell

Structural deficiencies, rain penetration, condensation, deteriorating concrete and poorly insulated external walls are the main problems associated with large panel system dwellings. Options for the buildings' future range from full repair and modernisation to demolition. Some (Figure 2) stand derelict awaiting a decision and financial resources. Others have been fully or partially overclad (Figures 3 and 4) in attempts to solve particular problems

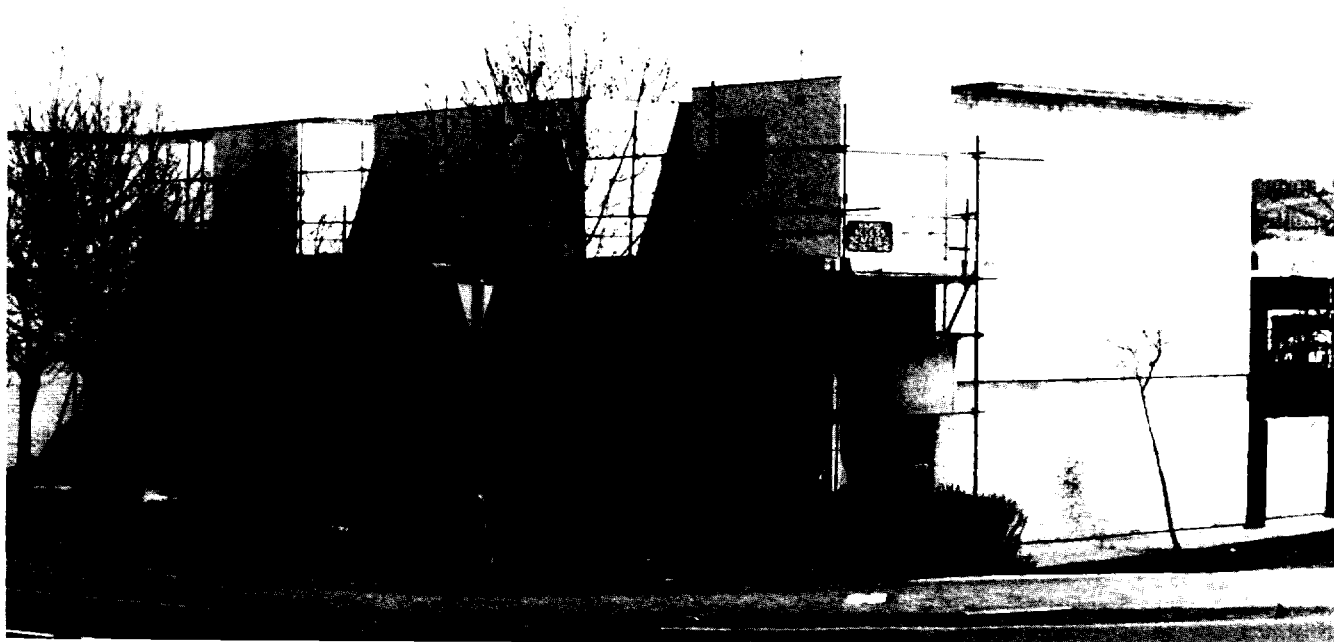
Figure 4 Rendering over thermal insulation at Gateshead

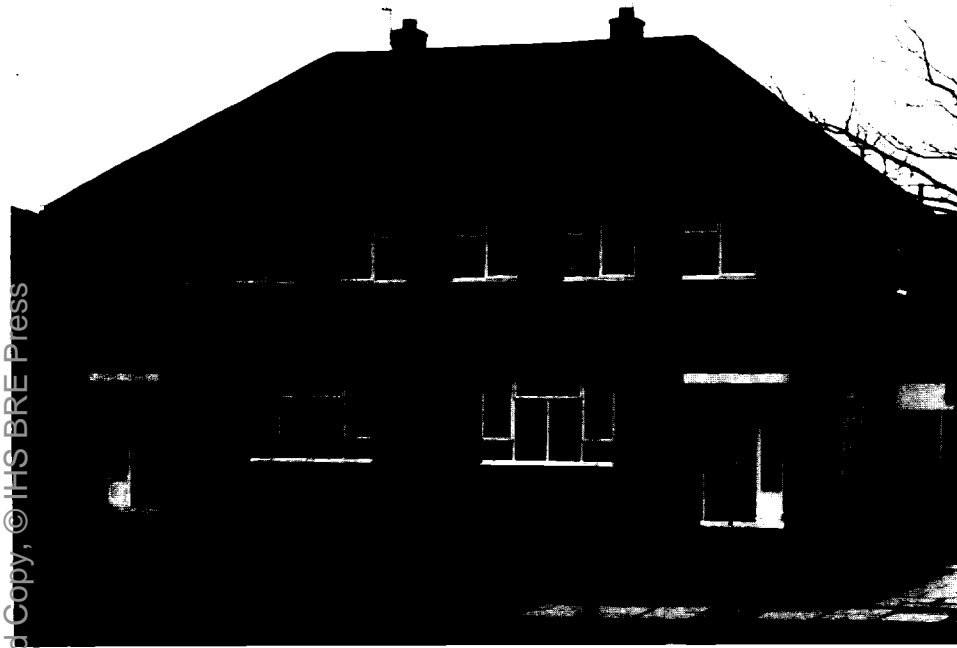
Figure 5 Stenni panels on Smiths houses at Sandwell

Not all LPS dwellings are high rise. Smiths houses have been fully overclad and externally insulated to improve their thermal insulation and appearance (Figure 5). Overcladding has also been used to prevent further deterioration of the gable end walls of non-LPS dwellings (Figure 6)

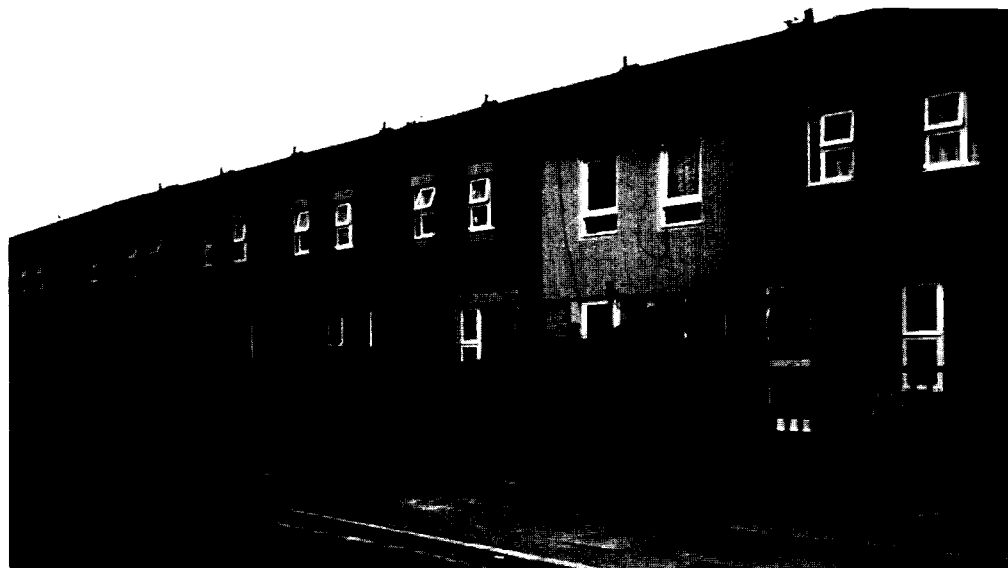
Figure 11 Bison terrace at Hartlepool where all properties but one have the same owner

Many authorities have reported difficulties either in persuading private owners to join overcladding schemes or in detailing satisfactory constructional solutions where they refuse

Many authorities have reported some difficulty in detailing constructional solutions between walls and roofs where properties are in different ownership, either in persuading the private owners to join the general refurbishing scheme (Figure 11) or in designing a satisfactory junction between dwellings where they will not (Figure 12).

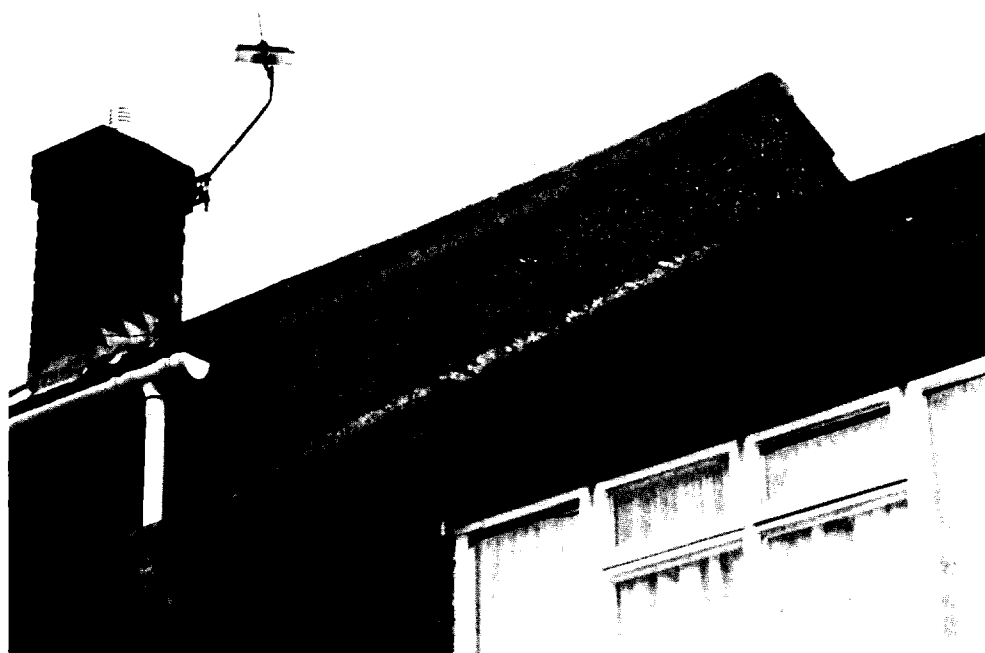
Figure 12 Detailing between adjoining properties with different owners

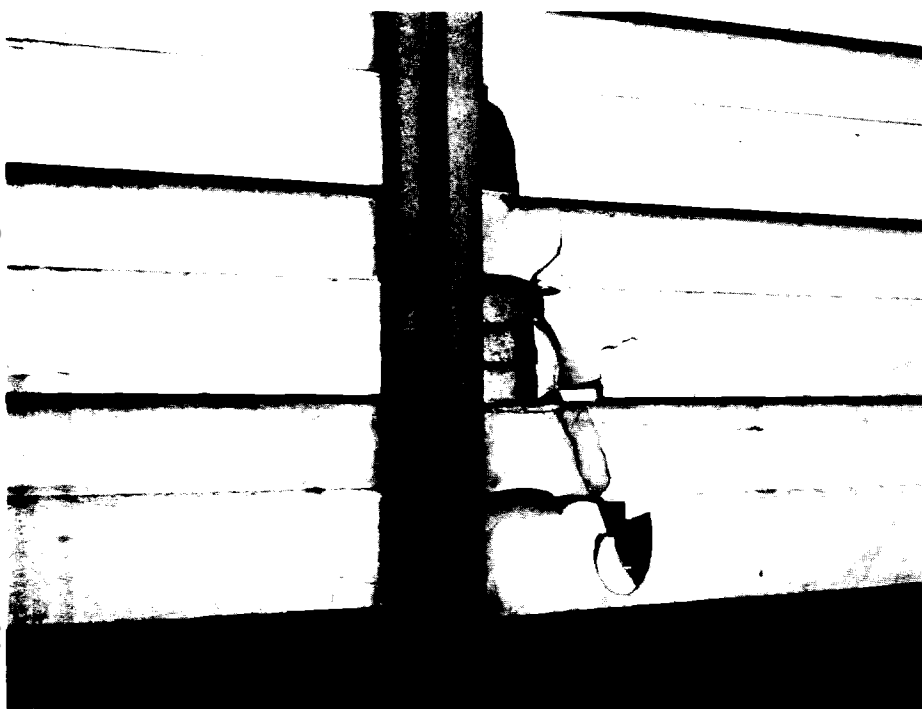
Material used for low-rise overcladding systems should meet the vandal-resistance criteria for impact or other abuses

Figure 36 Impact damage to uPVC sidings

Other finishing techniques which may be considered for low-rise systems include battens and sidings of, for example, wood, metal or uPVC. Sidings are not recommended at low level as they will not in general meet the vandal-resistance criteria for impact (Figure 36), or other abuse, eg prising off or even unscrewing accessible parts of the fixing system. Sidings of uPVC are also prone to colour changes or 'bloom' – both have been observed in BRE studies. Wood battens will need to be treated against rot.

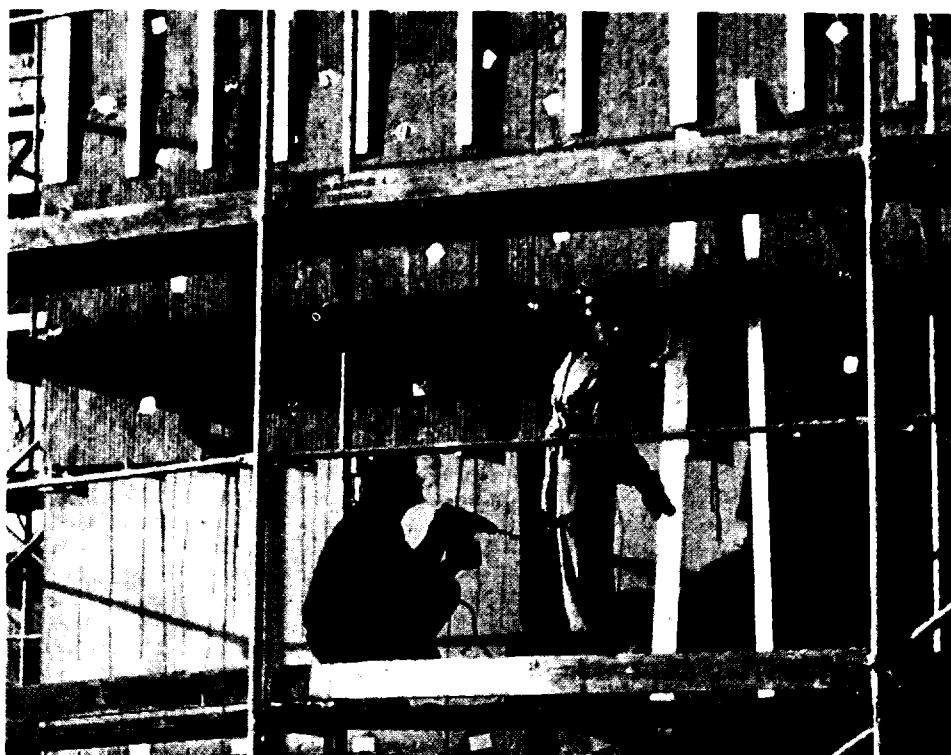
Figure 37 Sheet metals will need a secondary support system

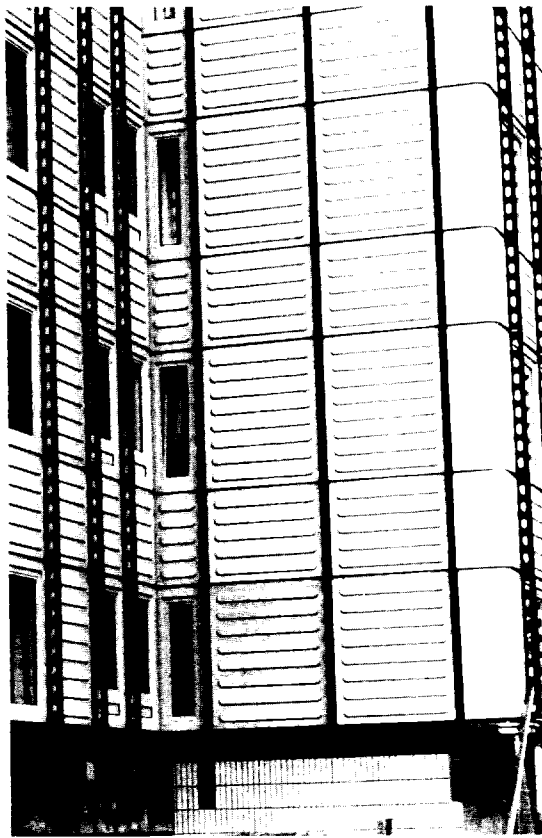
Figure 50

Cladding All-aluminium horizontally ribbed panels, with anti-drumming compound, clipped at six points to support spigots in aluminium alloy rails. Panels separately removable (Figures 49 and 50).

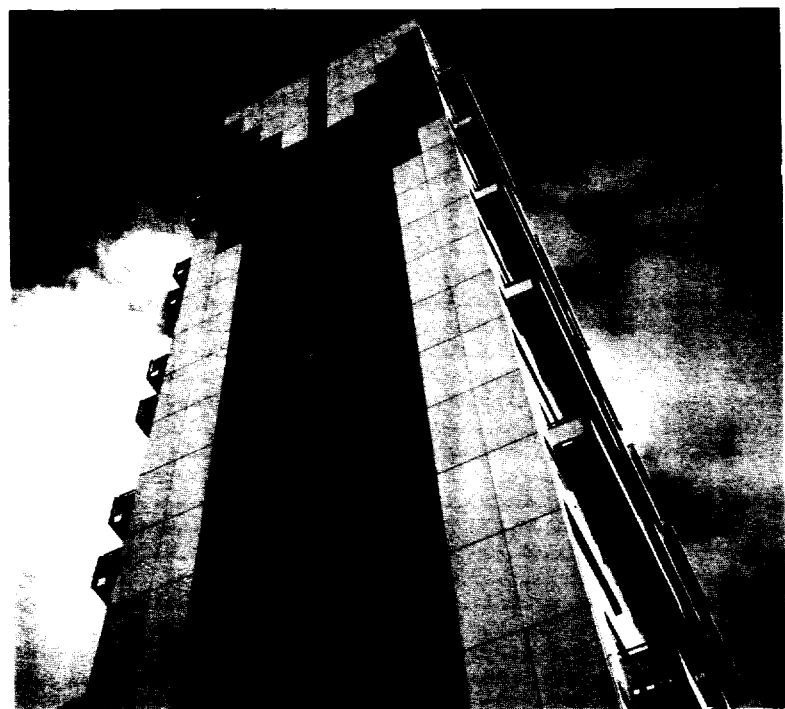
Figure 55

Cladding Eternit Ventisol Resoplan (melamine-surfaced plastics laminate) sheets pop riveted to aluminium rails. Horizontal joints have an aluminium chair section flashing. Neoprene seals, although not normally installed in this system, were used at panel junctions vertically. Cavity between the cladding and insulation is ventilated. (Figures 55 to 59)

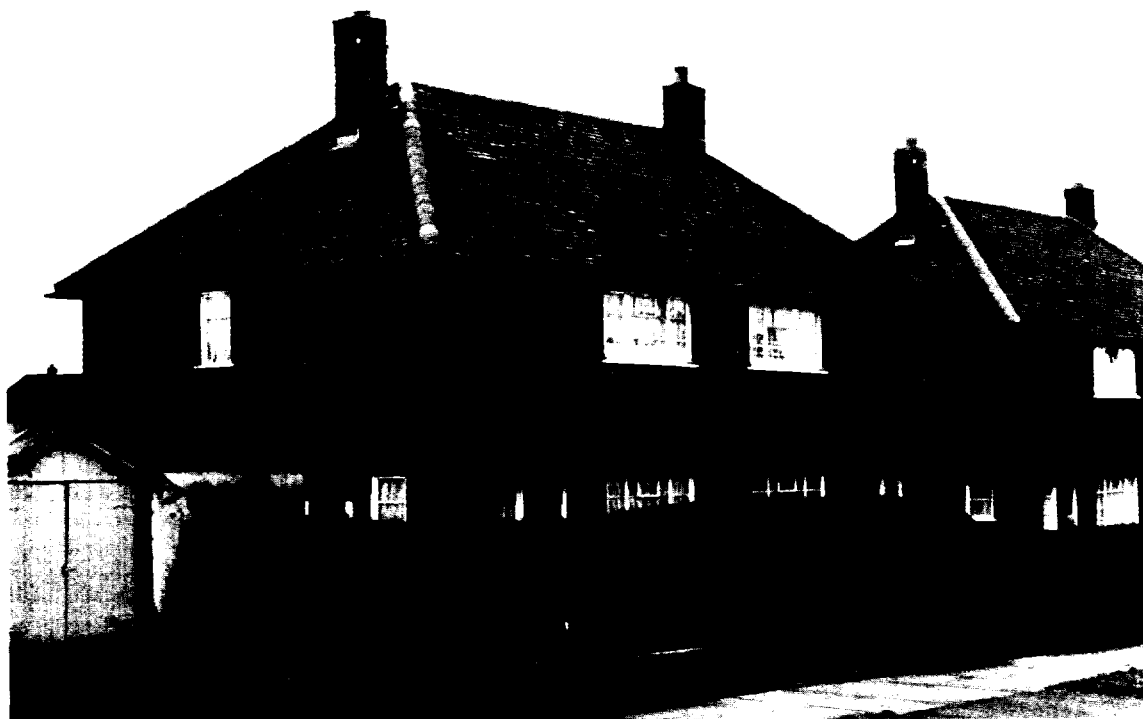
Defects before overcladding Difficult to heat. Thermal movement of concrete panels creating cracking where jointed, with cracks through brick slips. Corrosion of reinforcing steel in slabs causing spalling of concrete. Figure 60 shows original state.

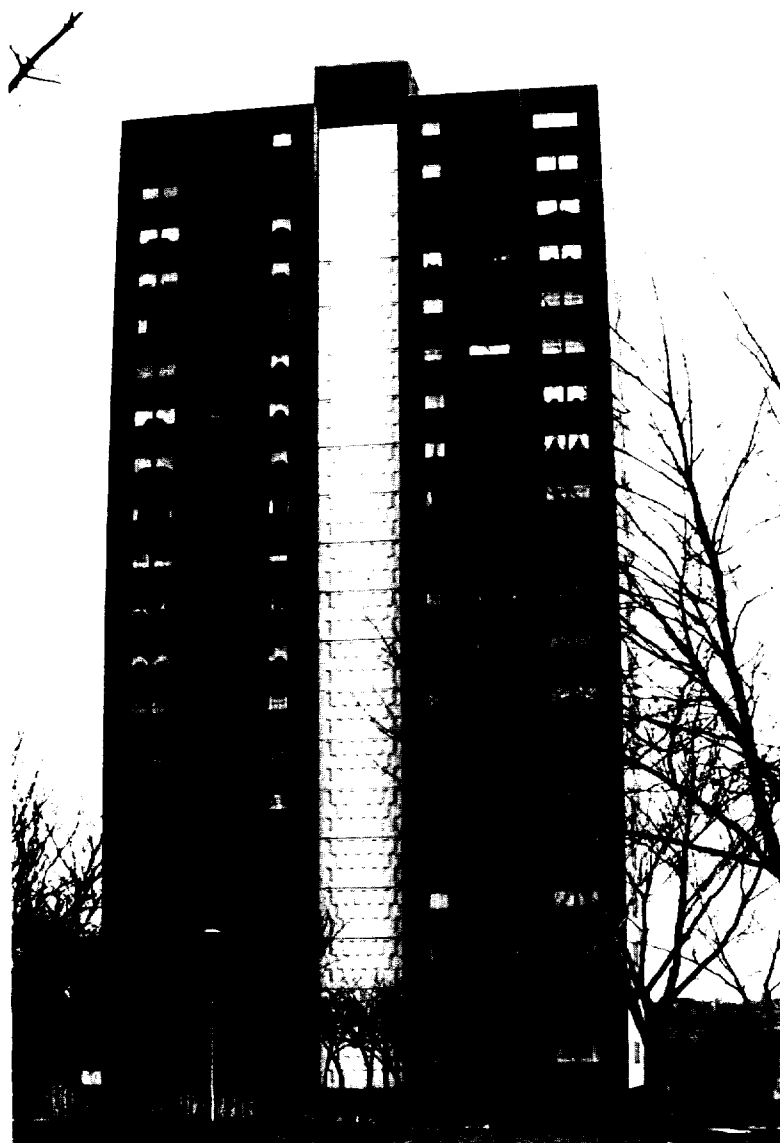
Figure 65

Cladding Two base coats and two finish coats, sprayed glass-reinforced plastics emulsion. Movement joints are inserted every other storey, and at regular intervals along the facade. Weep pipes to all window heads. Ground floor brick clad. (Figures 65 and 69.)

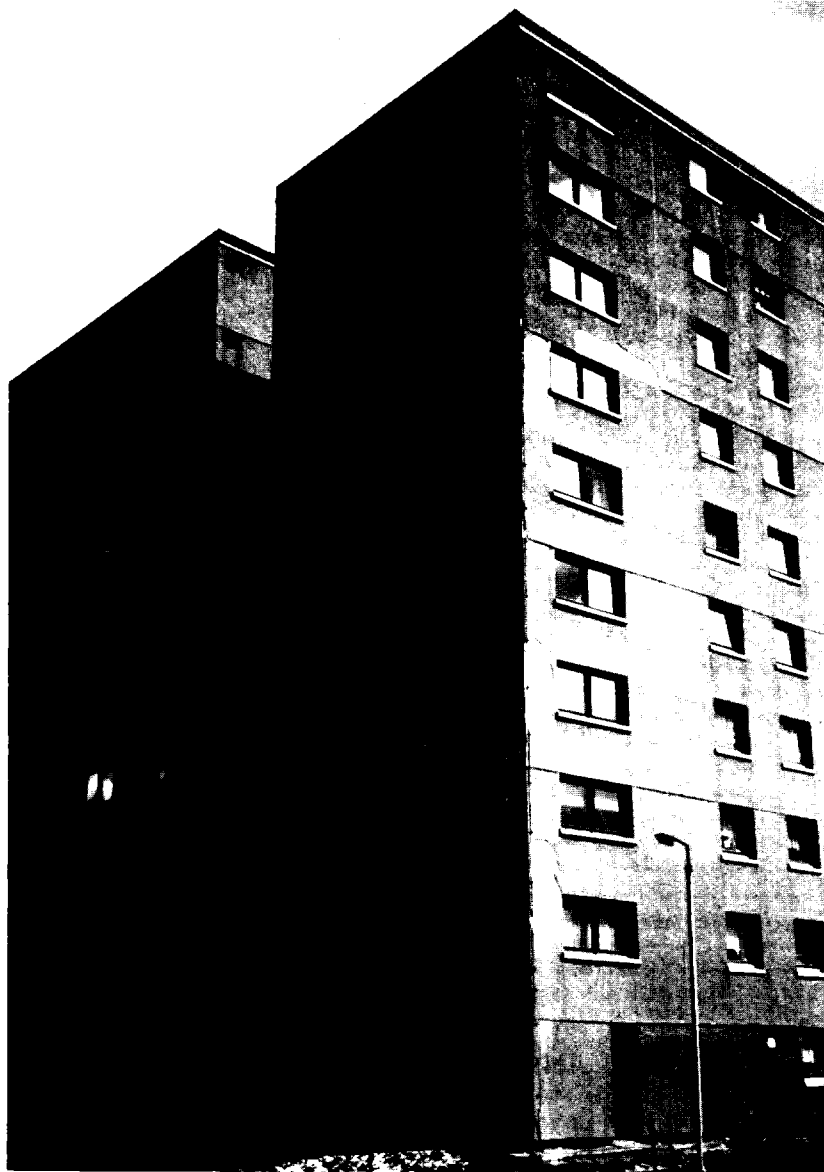
Figure 74

The first attempts at the remedial overcladding were applied in extremely poor weather conditions, and subsequently there have been delamination failures, with sheets of the material approximately 20 mm thick becoming detached (Figure 74). Most of the problems have been on the south and west elevations of the first block clad, but there have been less severe problems in other areas. Repairs have been attempted, which appear to have been reasonably successful, with the original faults largely cured.

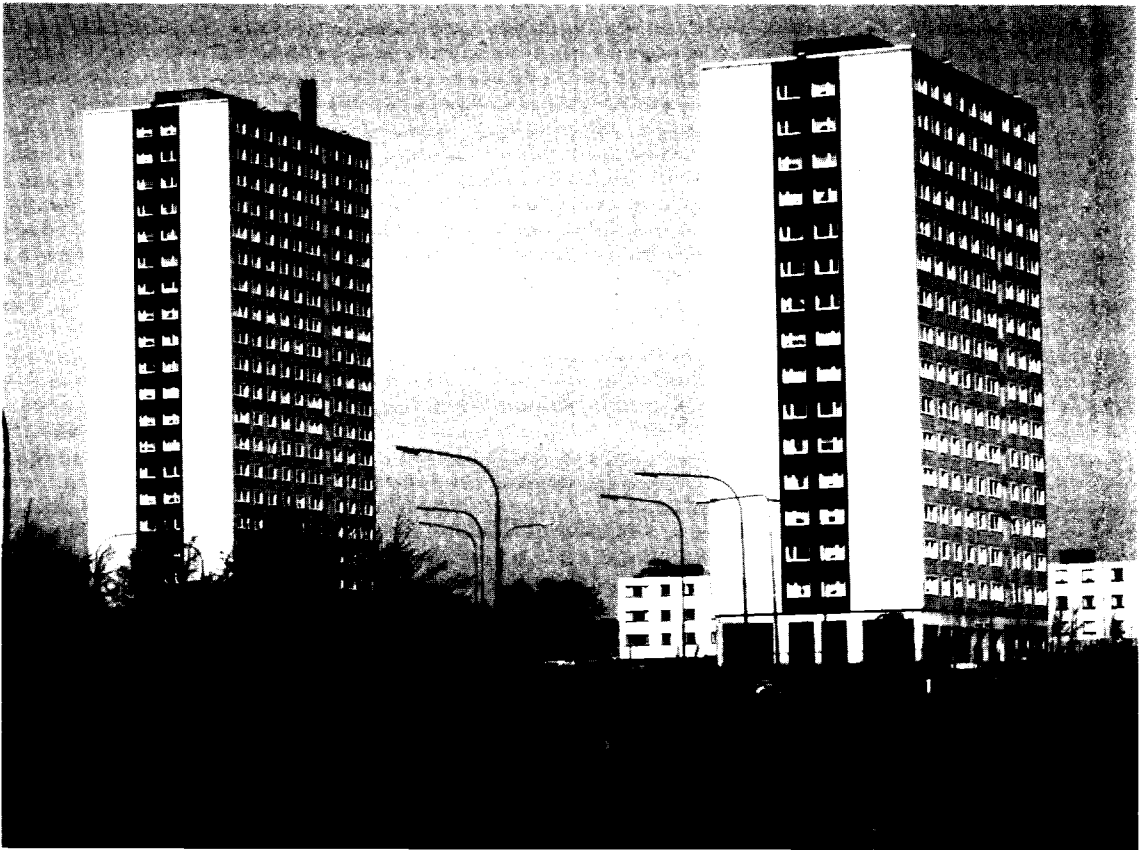
Figure 79

Cladding Horizontal stainless steel rails supporting profiled sheet aluminium, carried out on the south-west-facing gable ends only (Figure 79).

The cladding has uniform appearance, with no sign of any defects, and the rain penetration appears to have been cured.

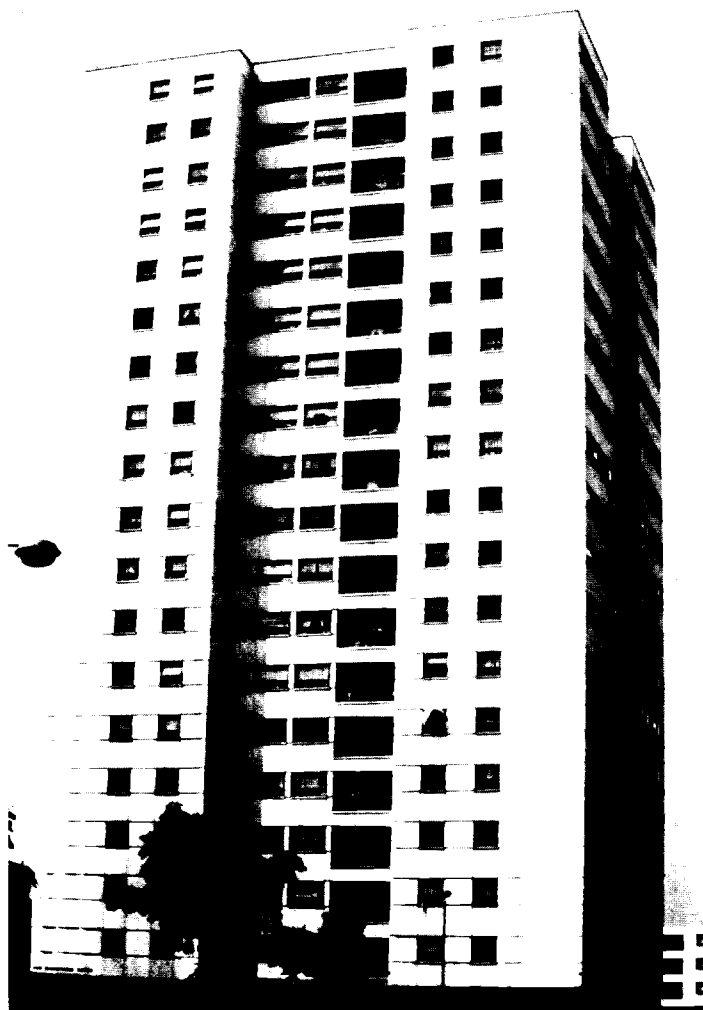
Figure 80

Cladding Eternit asbestos cement sheets screwed to asbestos cement vertical battens (Figure 80). The battens are held off the wall by Fischer plugs (Figure 81).

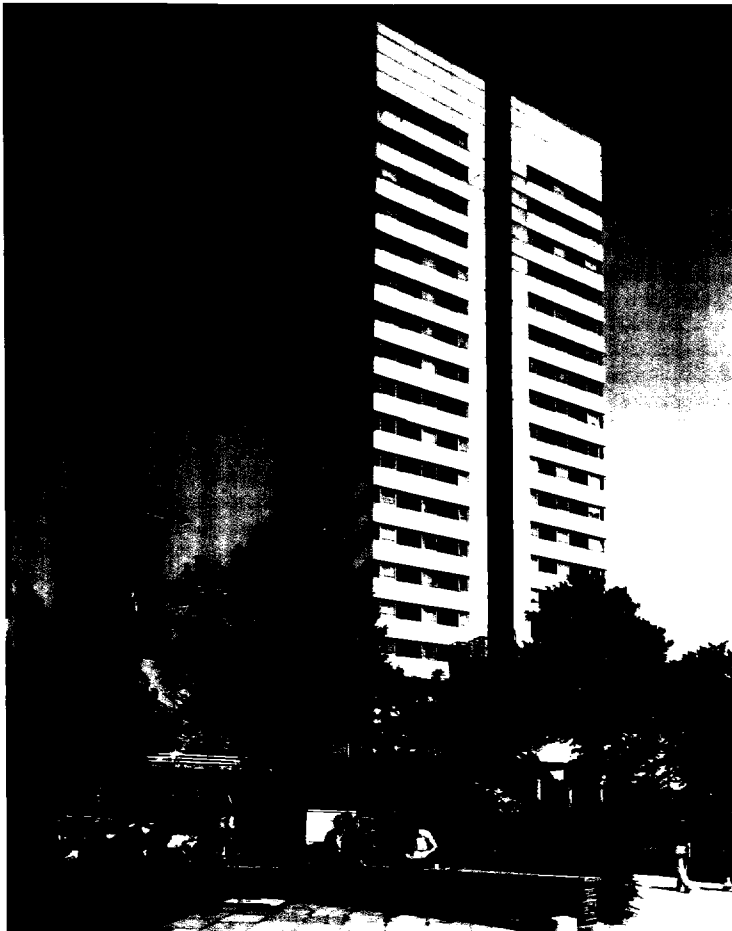
Figure 86

Cladding Specially formed dimpled aluminium panels fixed to aluminium frame, and bolted back to concrete panels (Figure 86). System designed to catch any further mosaic which might fall.

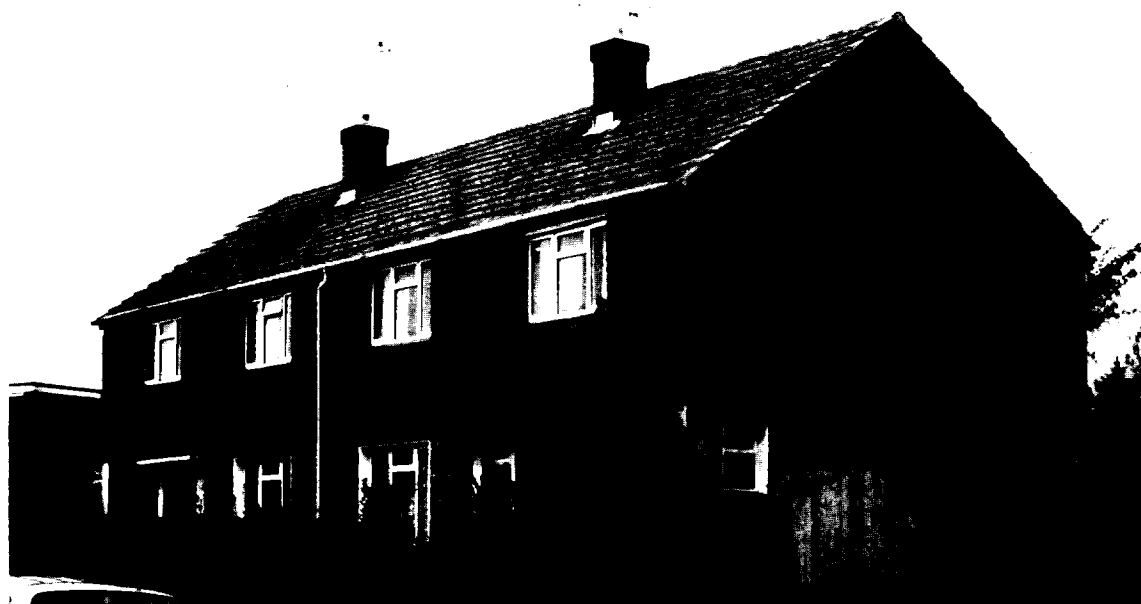
Figure 88

During 1983 and 1984, one pair of dwellings was overclad with 50 mm polystyrene thermal insulation board pushed in between softwood battens fixed to the no-fines wall. The ground-floor walls were finished with sand-cement render on 'Twill-lath', while the first-floor walls were finished in tile hanging. A subsequent trial used mathematical tiling in lieu of the rendering (Figure 88).

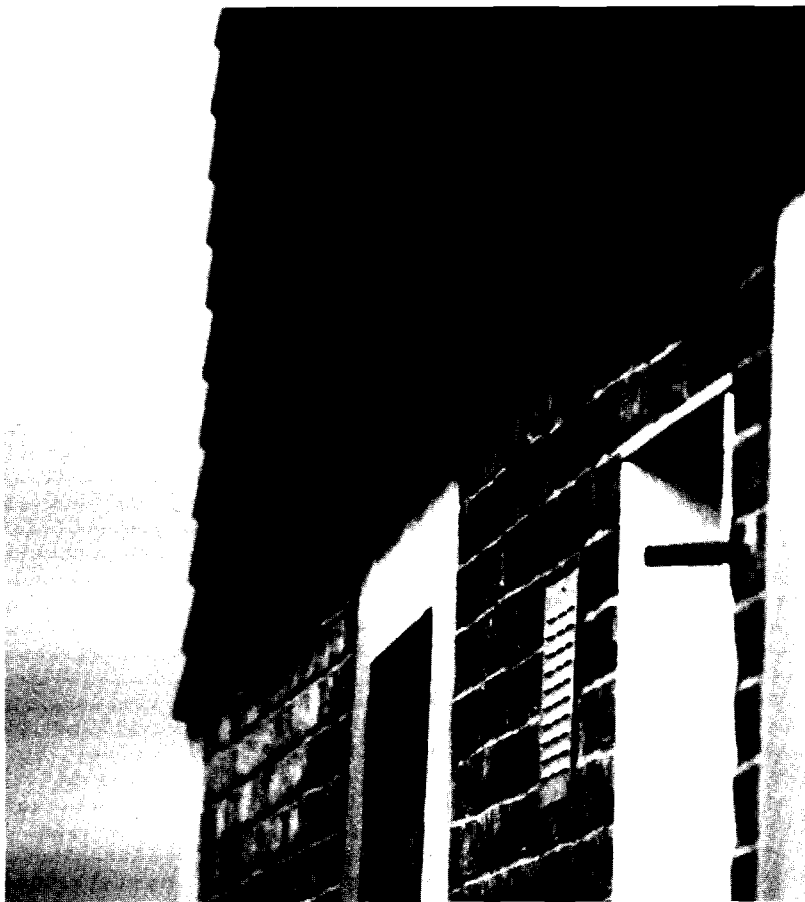
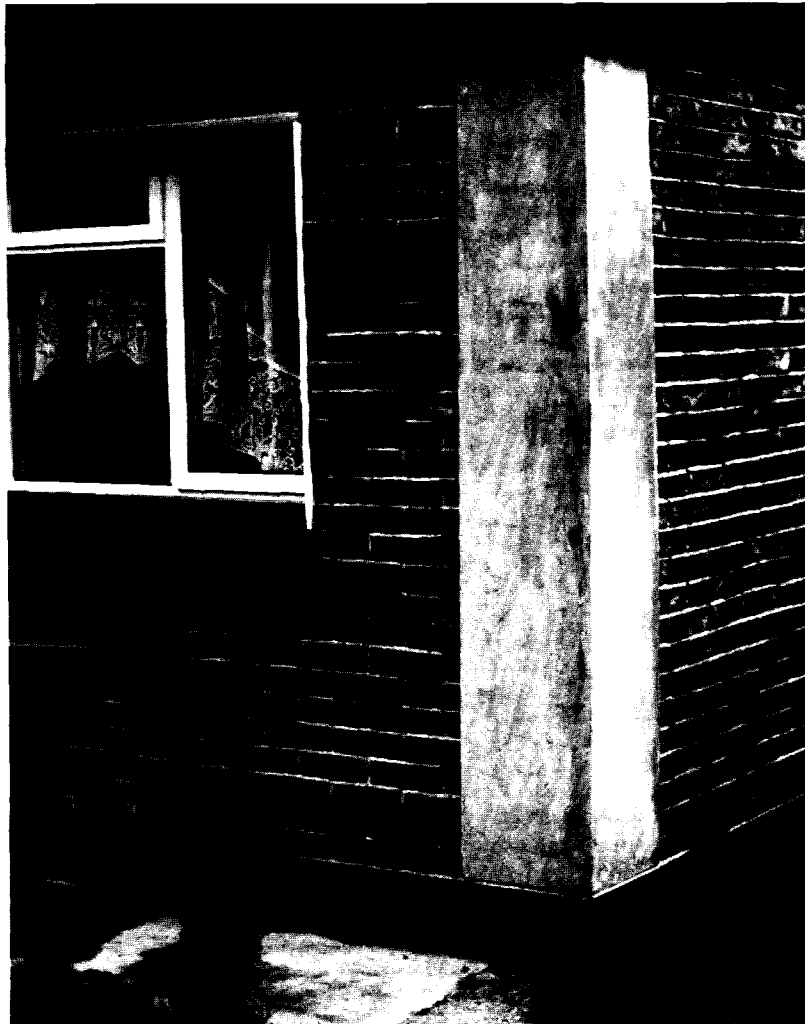
Neither scheme was deemed to be entirely satisfactory: the sand-cement rendering cracked, and the general appearance of the mathematical tiling was unacceptable (Figures 89 and 90).

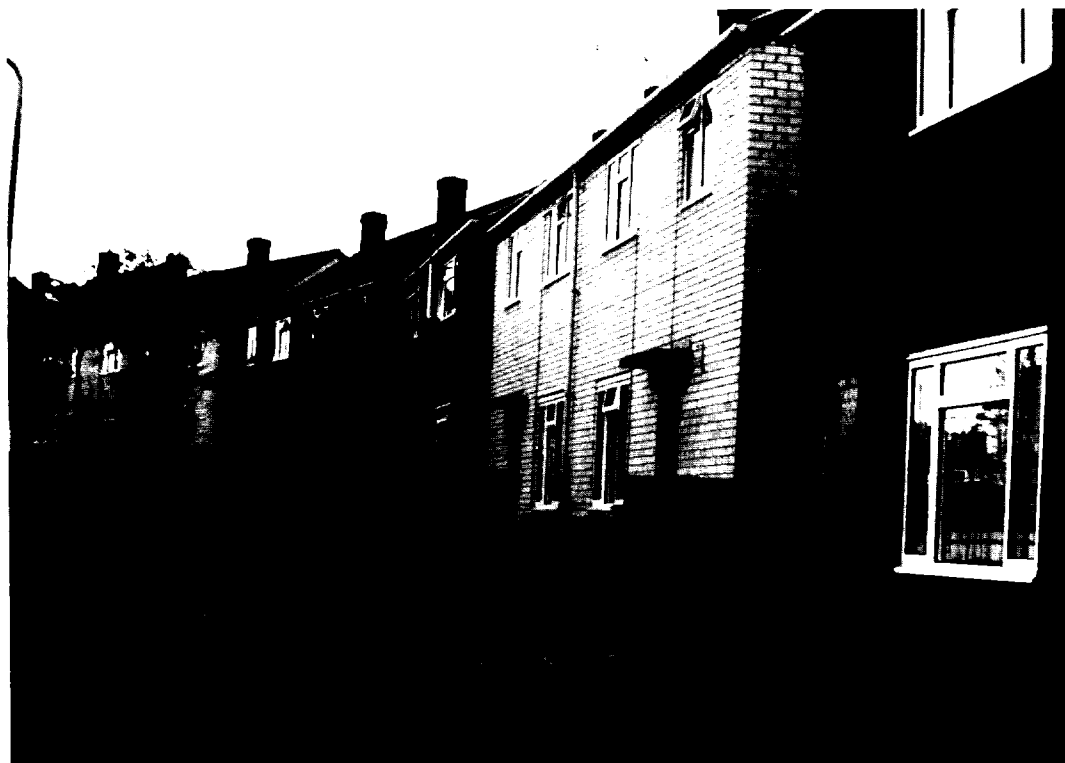
Figure 91

The final solution is to use a new outer leaf of brick or block (Figure 91) carried on extended foundations (Figure 92). The external wall includes 50 mm 'Dritherm' filled cavities. There is a small amount of masonry paint finish to the block walls which will need redecorating at regular intervals. This finish was used for aesthetic reasons.

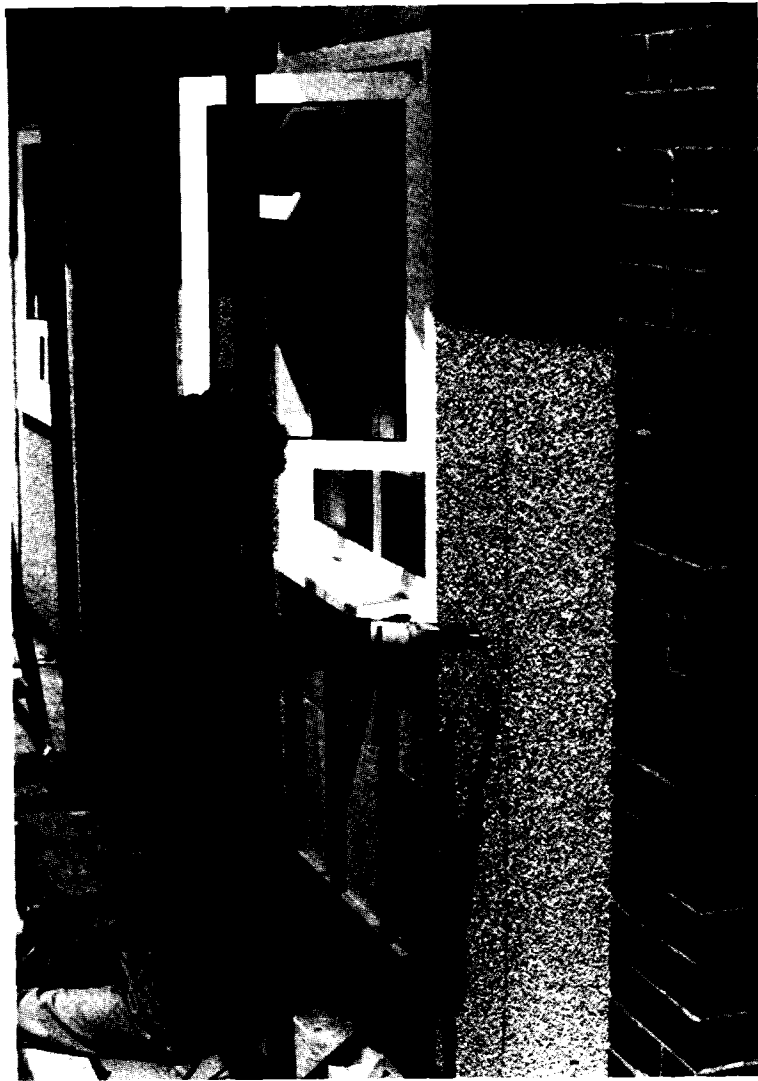
Figure 95

Cladding Stenni panels screwed to battens with stainless steel screws at 150 mm centres. All joints are bedded in mastic strips over the battens. The joints are filled with mastic, and finished with pieces of aggregate to blend with the surface (Figures 94 and 95).

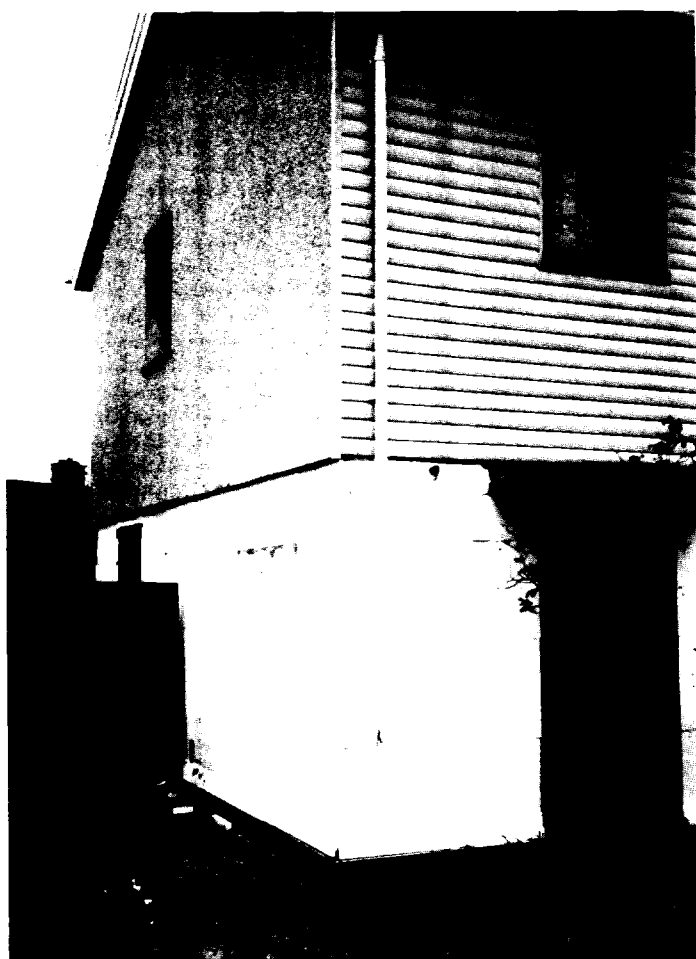
Figure 96

Thermal insulation First floor: 50 mm polystyrene boards fixed between 50 mm square timber battens. Ground floor: 40 mm polystyrene insulation glued over the original render (Figure 96).

The insulation appears to have been successful, and so far there have been no weather-tightness problems. There have, however, been colour-fastness problems with the brown-coloured shiplap used on the first dwellings. The white shiplap used later on appears to have fared better.

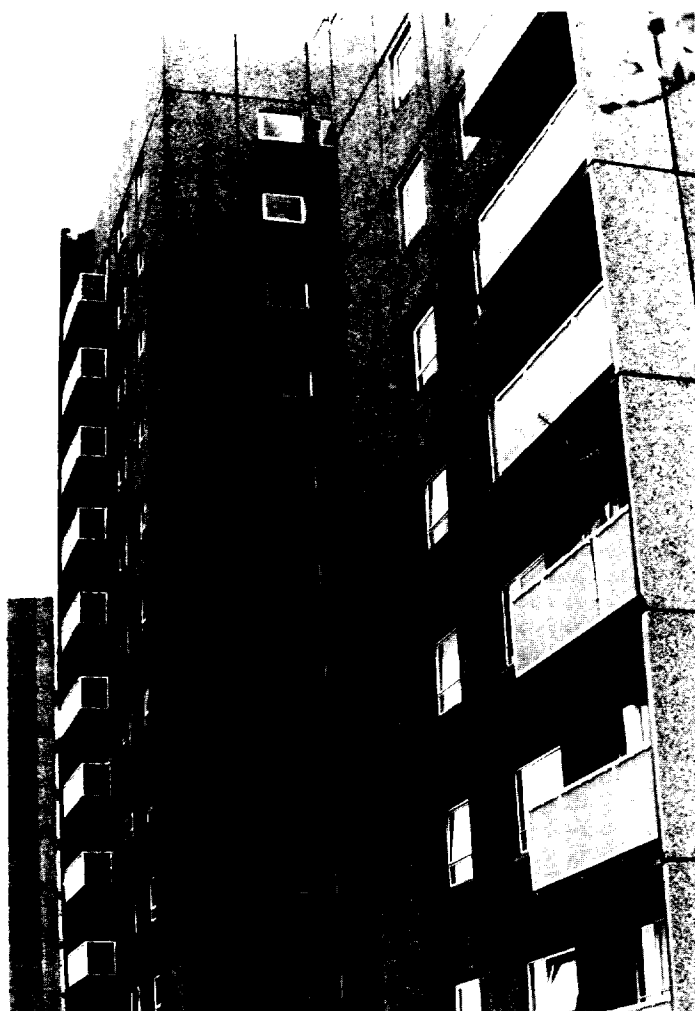
Figure 98

System Three 12-storey tower blocks built in the Reema system (Figure 98)

The original concrete cladding gave evidence of a number of problems, including cracking and spalling around window and door openings, spalling concrete around balustrades, including exposed reinforcement, broken corners of panels, and hair cracks on the external face of wall panels.

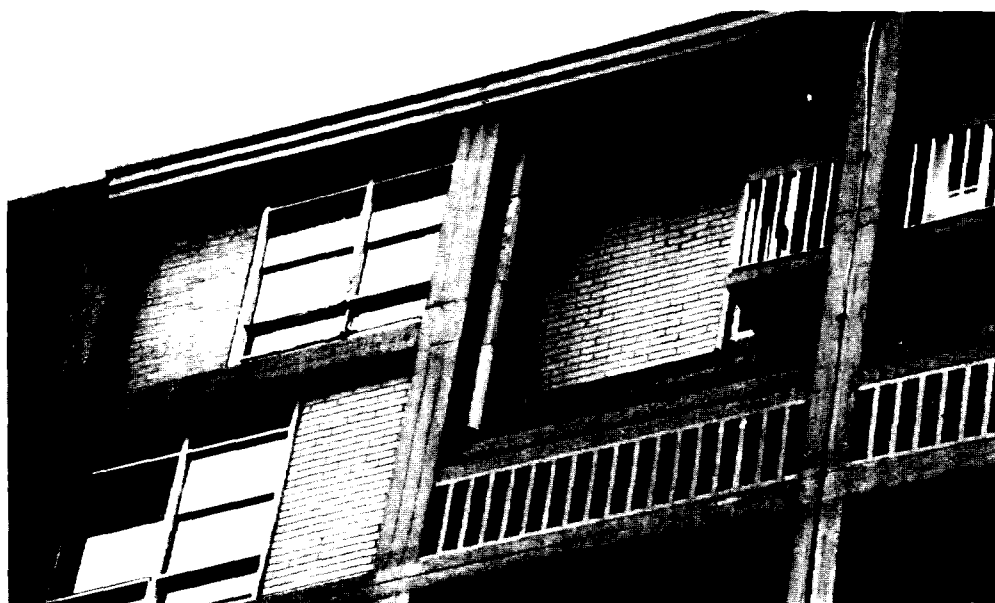
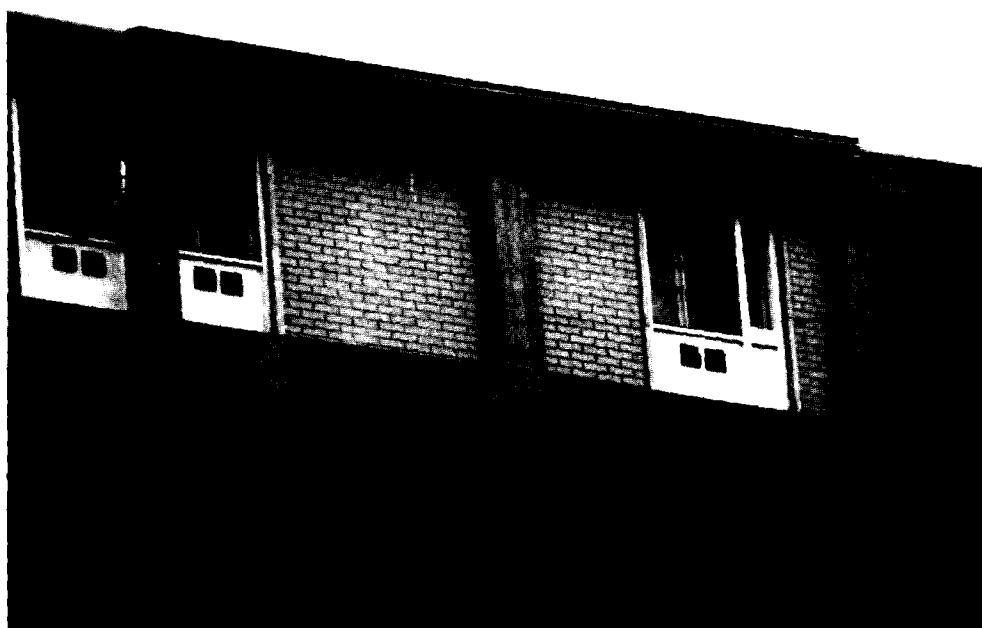
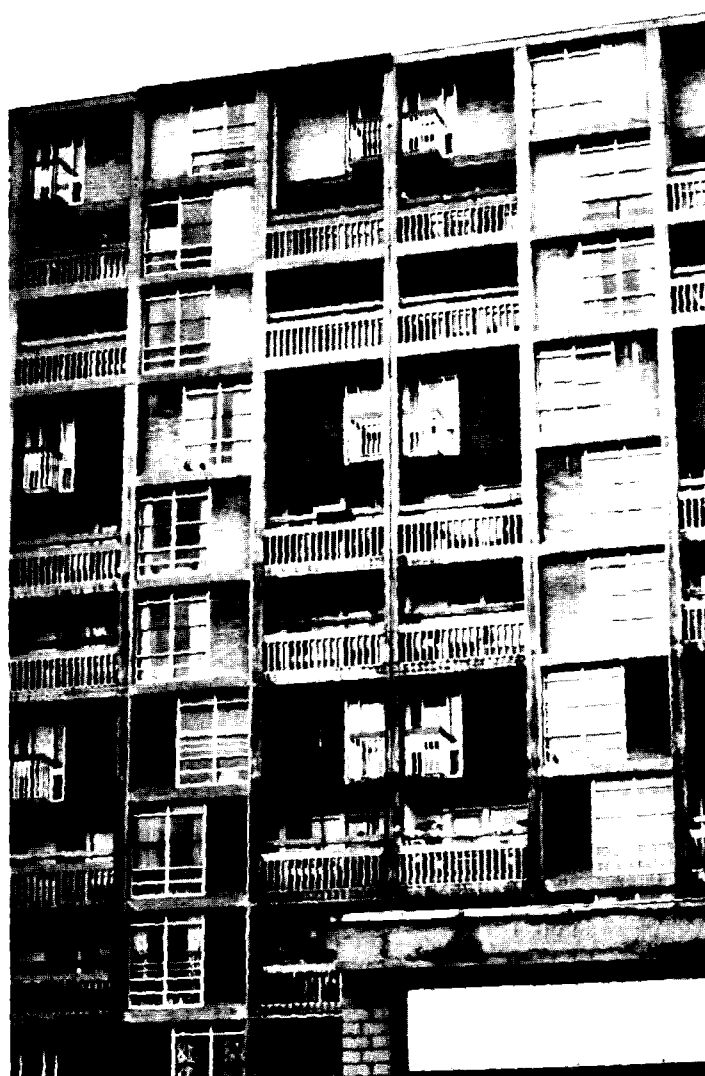
Overcladding the parapet around the roof edge beams with custom-made sheet aluminium cladding over Styrofoam thermal insulation (Figures 100 to 102). It is possible that an alternative thermal insulation would be injected later.

Overcladding the brick infill panels with 'Plasmor Thermostyle' fixed directly to the wall with stainless steel screws and bolts (Figures 100 to 102). The composite panel is faced with brick slips bonded with polymer-modified fibre-reinforced concrete to the tongued and grooved thermal insulations.

The proposal to overclad the parapet with aluminium alloy sheets should give the required performance. BRE has no first-hand knowledge of the performance of the brick-slip-faced panels: adhesion of the brick slips will be of crucial importance for durability.

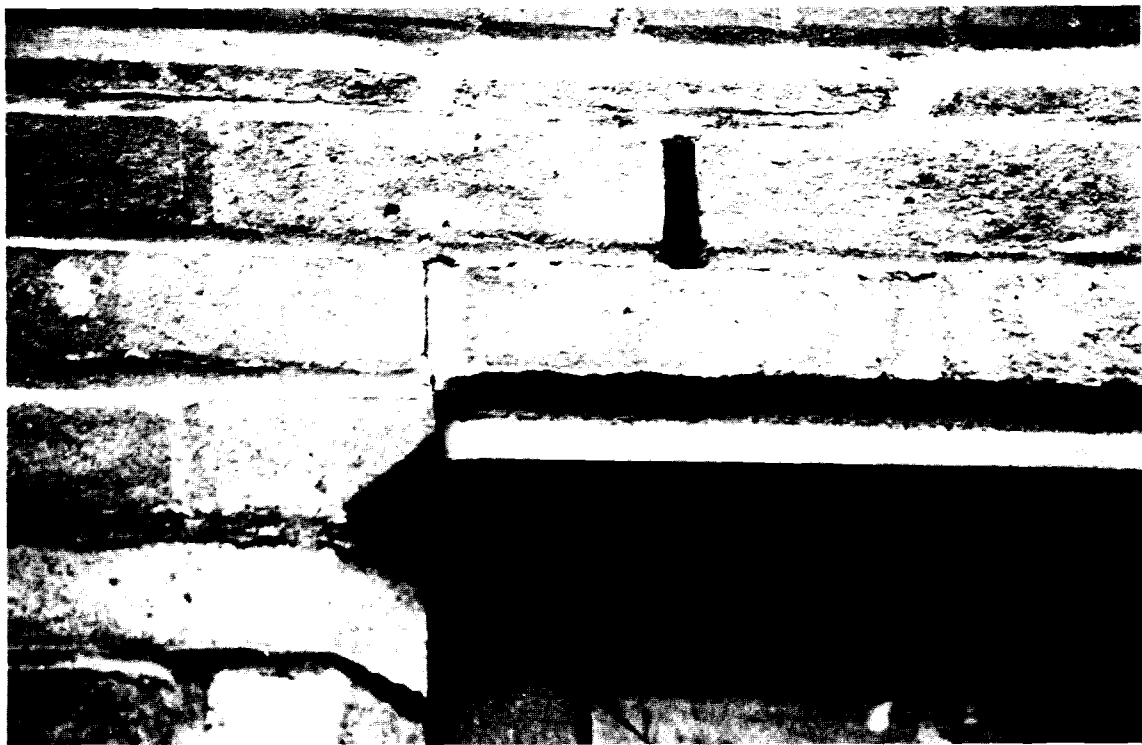
Figure 106

The work has only just been completed. Some minor cracking of brickwork has occurred at the ends of lintels (Figure 106) though the reason for this is not known, and also where movement joints have not been carried through (Figure 107).

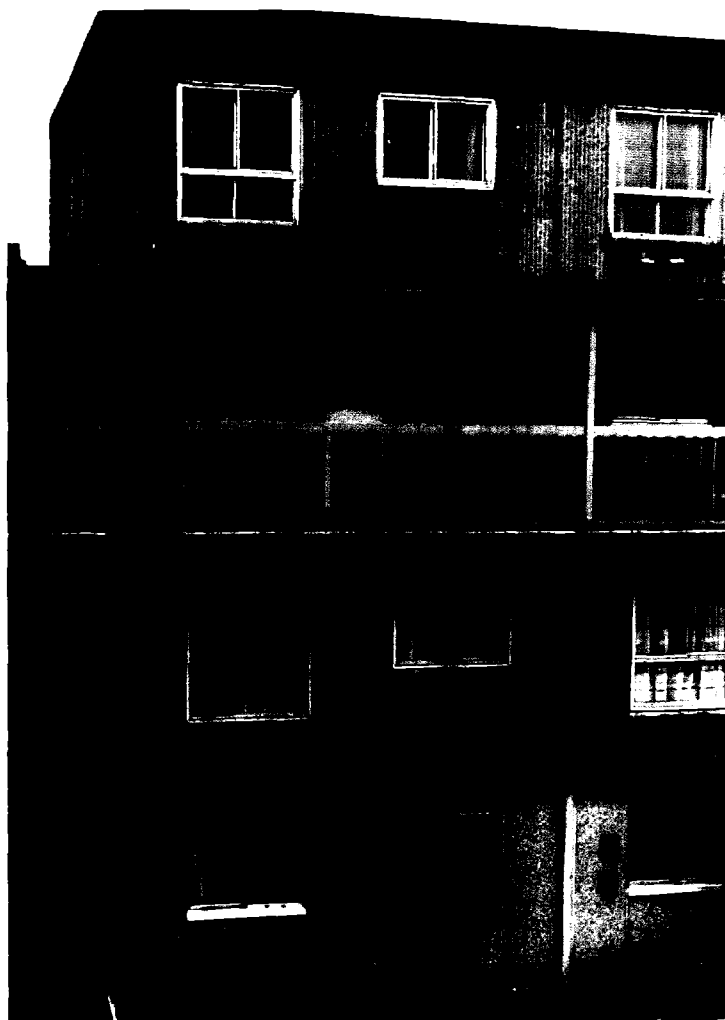
Figure 108

Defects before overcladding Leaking baffle joints, carbonation, drab appearance (Figure 108).

The system required structural strengthening, and this was accomplished by steel angles bolted through the structure. It proved difficult to disguise the repairs. The original open-drained joints had leaked, and various patching repairs had not proved successful. It was therefore decided to convert the joints into a face-sealed system, and overcoat the whole of the concrete with a durable finish which would keep the concrete dry and reduce the future rate of carbonation.
